Natural Draft Cooling Tower - Mantle Inspection & Repair

Andrew Kelly ICIQB B.Sc.

This paper reviews the background, repair scheme, access and methodology deployed in the repair of a Hyperbolic Cooling Tower at The E.On Ratcliffe-On-soar 2000MW Coal-fired Generating Station in Nottinghamshire, England. See Figure 1

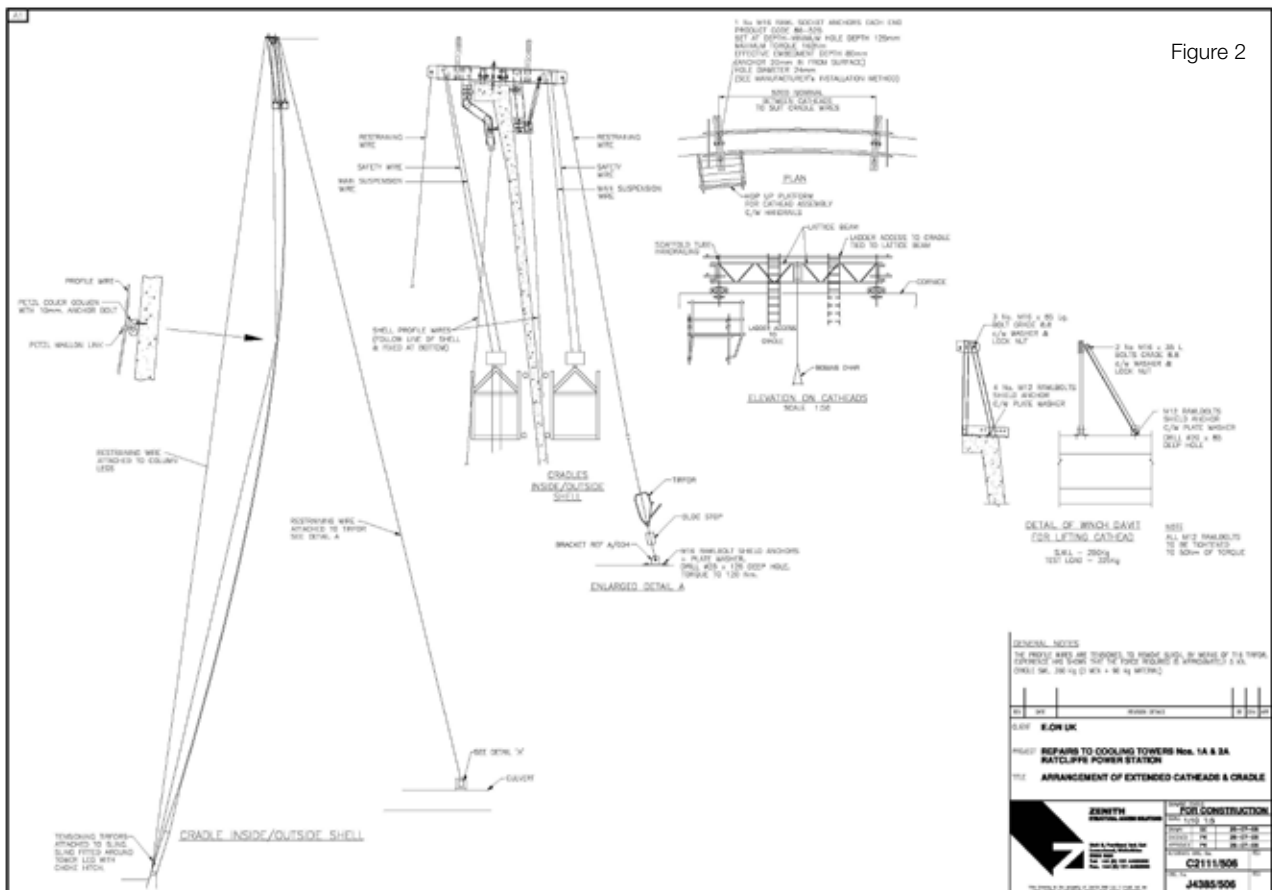
The cradle platform follows the tower profile by the use of temporary wires fixed into the shell and tensioned at ground level. When moving the system circumferentially around tower the tension of the counter weight anchorage is marginally released. The system can then be re-positioned to the next vertical working position.

The system deployed ensures that all surfaces of the tower can be accessed externally and internally with only marginal effort.

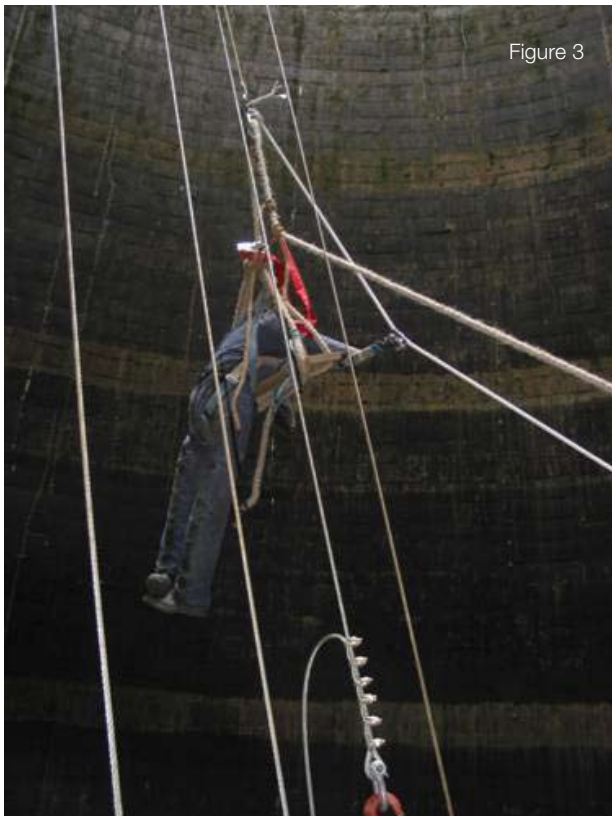
Figure 3

In conjunction with the client's safety team, Zenith developed a safe system for rescue including every potential scenario. A mock demonstration was completed at site with all parties to the contract satisfied. On completion of the mock demonstration, the work could then proceed.

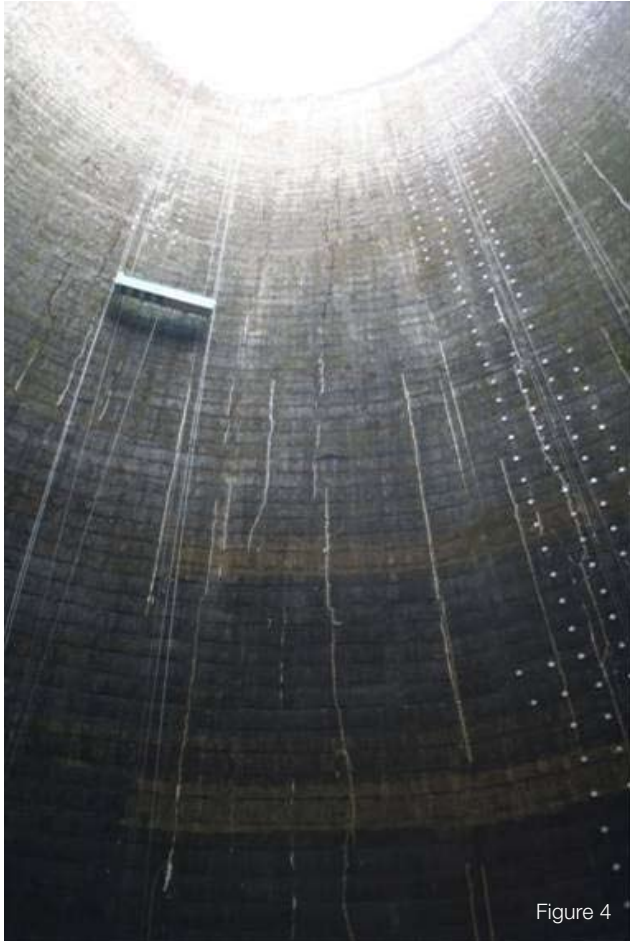
Figure 4

The procedure adopted required the drilling of holes to the depth of the delamination at pre-determined locations throughout the repair zone. The grout was batched at ground level and pumped to the workface using a grouting machine and pump. Careful monitoring of delivery pressure was completed to ensure the parameters of the specification were not exceeded. Grout was delivered to the lowest position of the repair zone until the grout had filled to that position. Once the void had been filled the process was repeated progressively up the tower moving in vertical and horizontal planes depending upon the now established repair zone. The procedure continued until the repair zone was grouted in full.

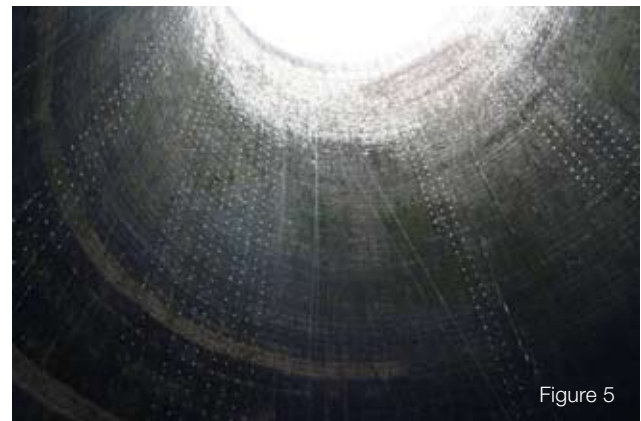
Figure 5

The grouting technique adopted proved to be a practical solution to a major repair scheme.
