Re-strengthening of reinforced concrete chimney

This paper reviews the background, philosophy, repair scheme, scope and methodology used in the inspection and re-strengthening of a reinforced concrete chimney.

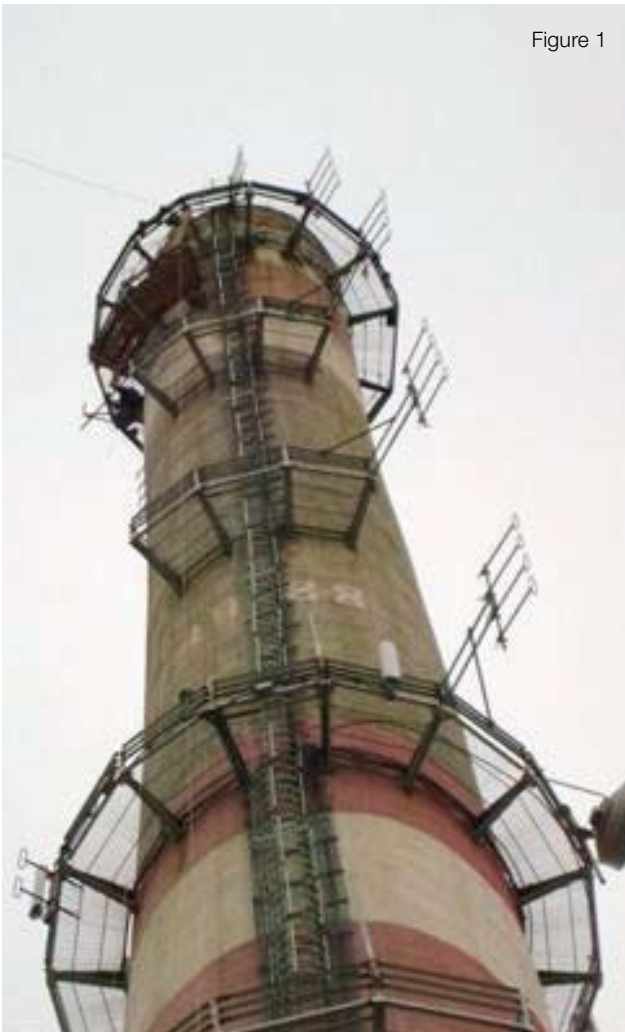
Figure 1

This particular structure was constructed and commissioned in 1984 and has suffered from the absence of a proactive inspection and maintenance plan. (Figure1).

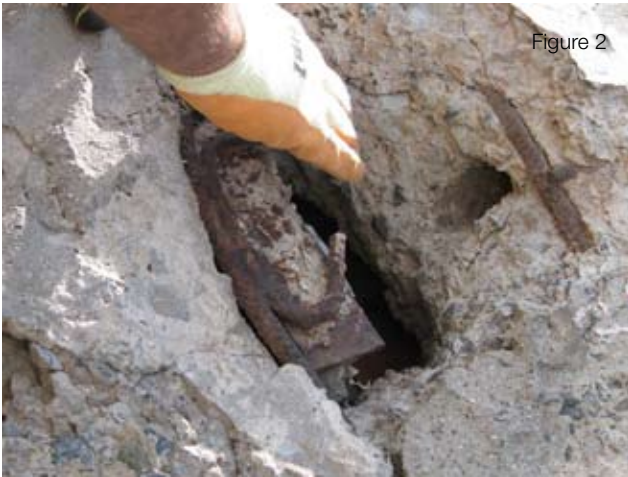
Figure 2

The uppermost section of the concrete windshield was found to be in a very poor condition. The reinforced concrete was found to be porous with large sections of spalling and decaying concrete noted throughout. Cavities through the windshield were found in three different elevations (Figure 2). Reinforcement steel was found in a serviceable condition but the concrete was now in a state of disrepair (Figure 3). The capping detail was found to be serviceable.

The strength and durability of the top of the chimney windshield was deemed to have weakened significantly and required re-strengthening. A number of options were available.

However, in this environment and taking into account the resources available the preferred option was to re-strengthen the top of the chimney with a 'sheath' or cladding of steel and cementitious concrete grout. This technique has been used in a number of similar projects where there has been general degradation over the full circumference for a relatively short distance from the top. The steel sheath compensates for the loss of steel reinforcement and all that is required of the existing concrete is a very limited compression capacity. At the top of the chimney, the main loading is in the circumferential direction and for this reason, the plates are butt welded on the vertical joints. A fillet weld suffices for the connecting the plates on the horizontal joints as there is little loading in the vertical direction in this region.

This sheath was designed with a 50 mm nominal cavity between the new steel sheath and the original concrete substrate. The cavity was filled with a non-shrink cementitious grout.
