Introduction

This paper reviews the background, repair scheme, access and methodology deployed in the repair of a Hyperbolic Cooling Tower at The E.On Ratcliffe-On-soar 2000MW Coal-fired Generating Station in Nottinghamshire, England. See Figure 1

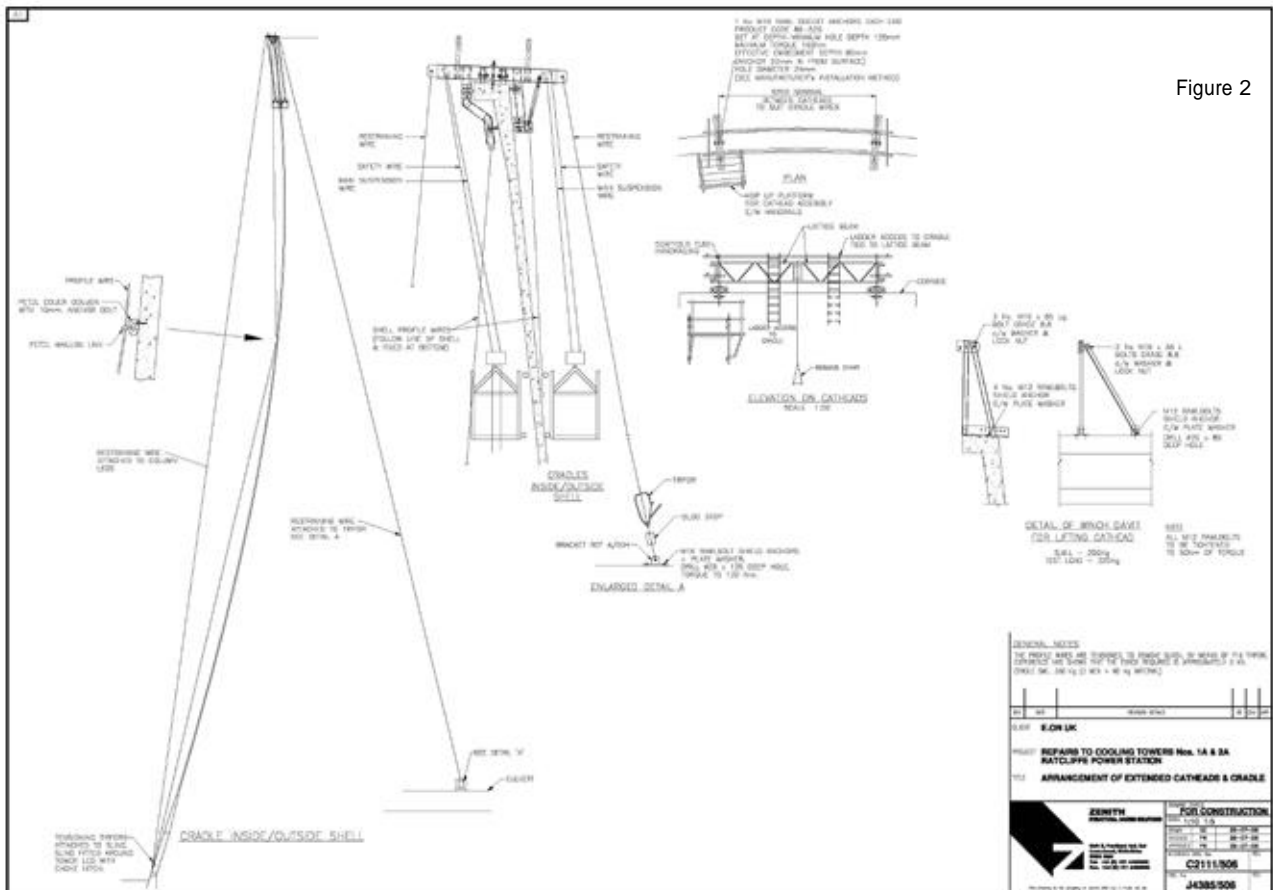
The cathead system is piecemeal constructed at the top of the tower. The manageable components are hoisted into position via a traditional winch system and lifting davit. The cathead system is assembled in sections to form one continuous unit. The system is counter balanced with an internally located weight or anchorage.

The cradle platform follows the tower profile by the use of temporary wires fixed into the shell and tensioned at ground level. When moving the system circumferentially around tower the tension of the counter weight anchorage is marginally released. The system can then be re-positioned to the next vertical working position.

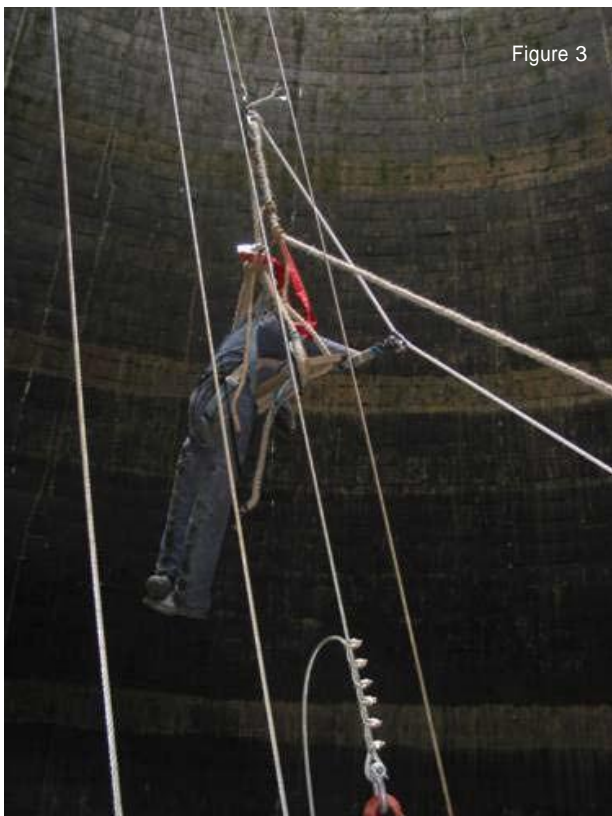
Figure 3

In conjunction with the client's safety team, Zenith developed a safe system for rescue including every potential scenario. A mock demonstration was completed at site with all parties to the contract satisfied. On completion of the mock demonstration, the work could then proceed.

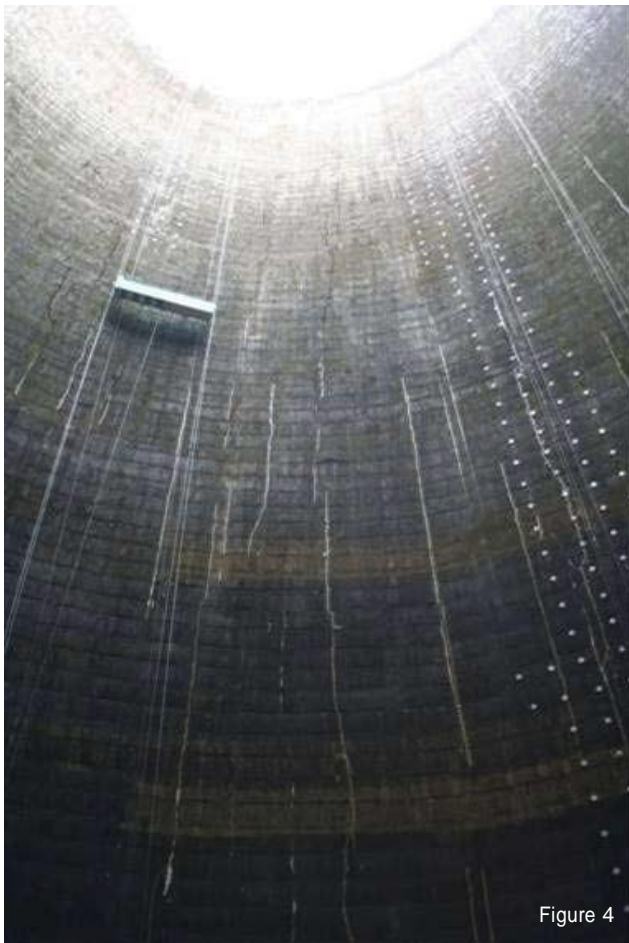
Figure 4

The procedure adopted required the drilling of holes to the depth of the delamination at pre-determined locations throughout the repair zone. The grout was batched at ground level and pumped to the workface using a grouting machine and pump. Careful monitoring of delivery pressure was completed to ensure the parameters of the specification were not exceeded. Grout was delivered to the lowest position of the repair zone until the grout had filled to that position. Once the void had been filled the process was repeated progressively up the tower moving in vertical and horizontal planes depending upon the now established repair zone. The procedure continued until the repair zone was grouted in full.

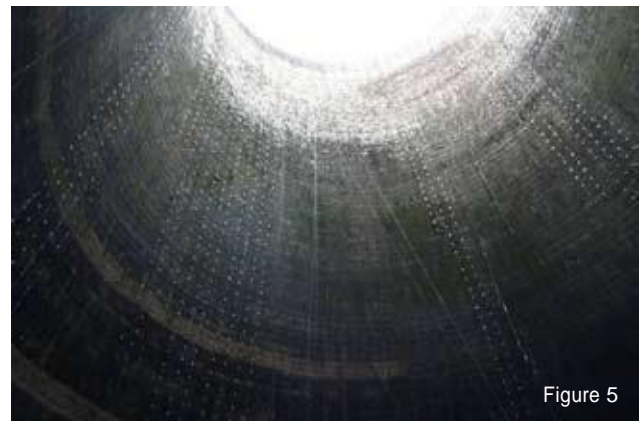
Figure 5

The grouting technique adopted proved to be a practical solution to a major repair scheme.
