# ZENITH

## Re-strengthening of reinforced concrete chimney

This paper reviews the background, philosophy, repair scheme, scope and methodology used in the inspection and re-strengthening of a reinforced concrete chimney.

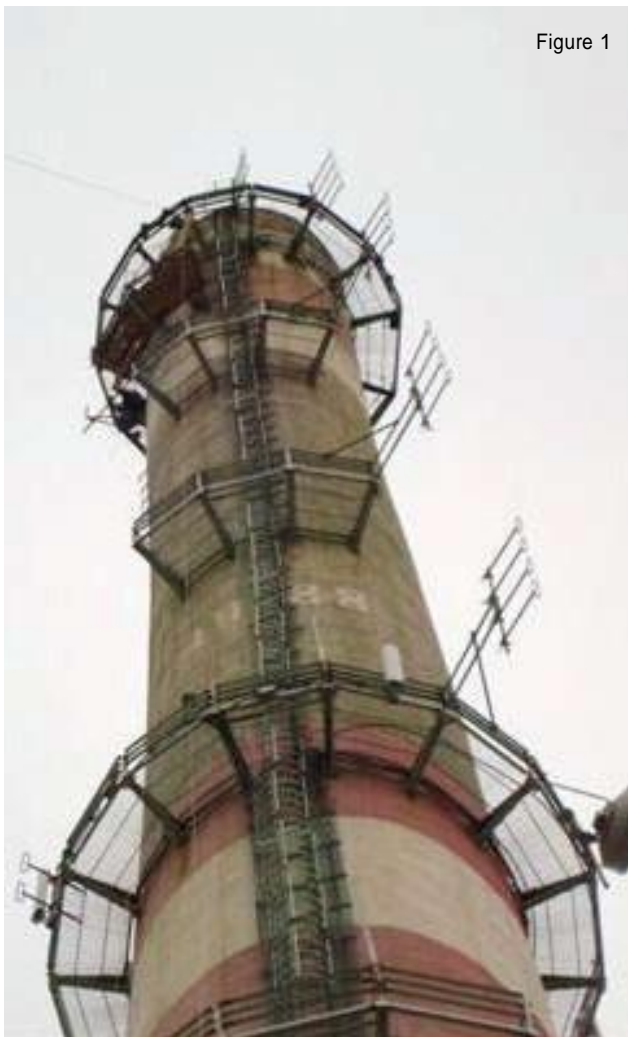
Figure 1

This particular structure was constructed and commissioned in 1984 and has suffered from the absence of a proactive inspection and maintenance plan. (Figure1).

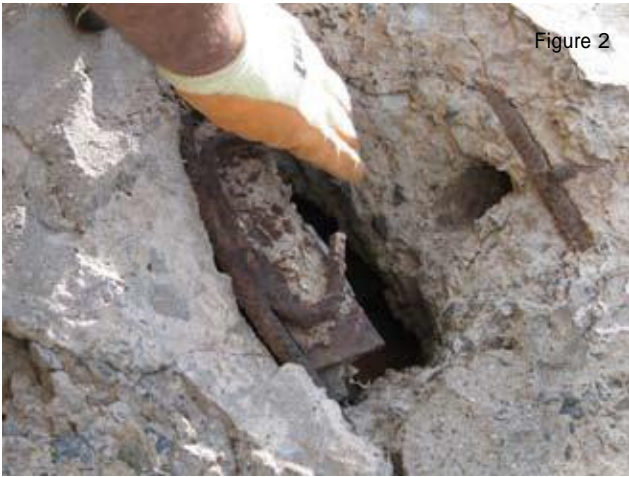
Figure 2

The uppermost section of the concrete windshield was found to be in a very poor condition. The reinforced concrete was found to be porous with large sections of spalling and decaying concrete noted throughout. Cavities through the windshield were found in three different elevations (Figure 2). Reinforcement steel was found in a serviceable condition but the concrete was now in a state of disrepair (Figure 3). The capping detail was found to be serviceable.
