ZENITH

FRP Repair to a Reinforced Concrete Chimney

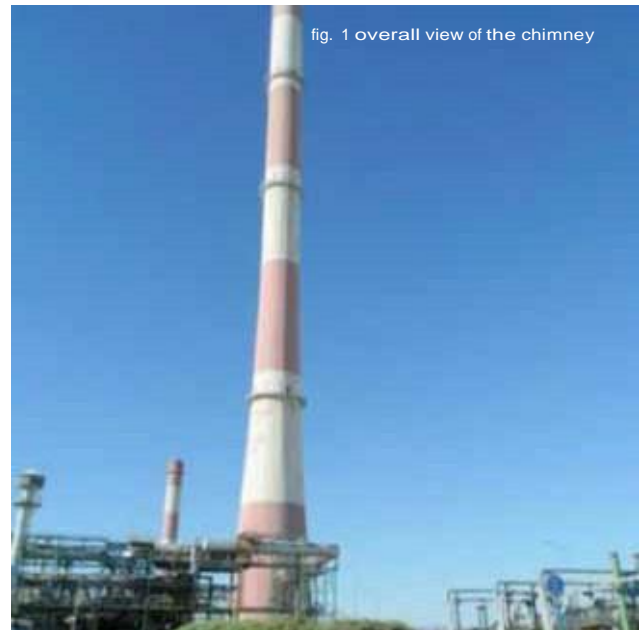
This particular structure was constructed and commissioned in 1984 and has suffered from the absence of a proactive inspection and maintenance plan. (Figure 1)

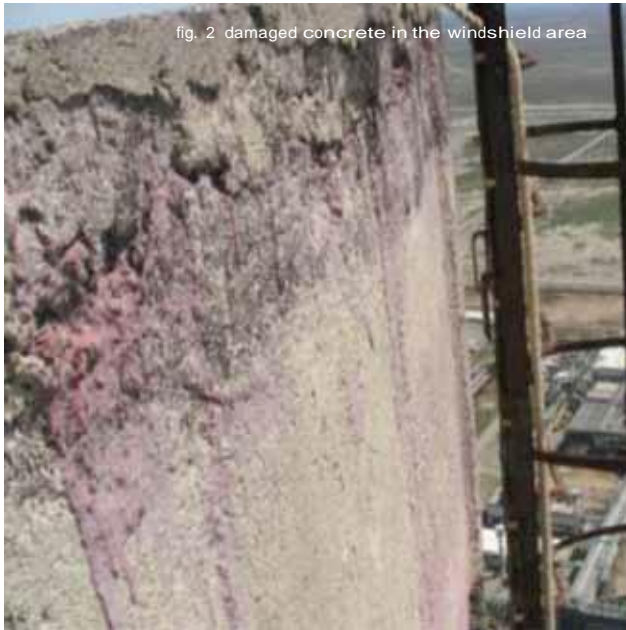
The uppermost 5 meter section of the concrete windshield was found to be in a very poor condition. The reinforced concrete was found to be porous with large sections of spalling and decaying concrete noted throughout. Cavities through the windshield were found in three different elevations (Figure 2). Reinforcement steel was found in a serviceable condition but the concrete was now in a state of disrepair (Figure 3).

fig. 2 damaged concrete in the windshield area

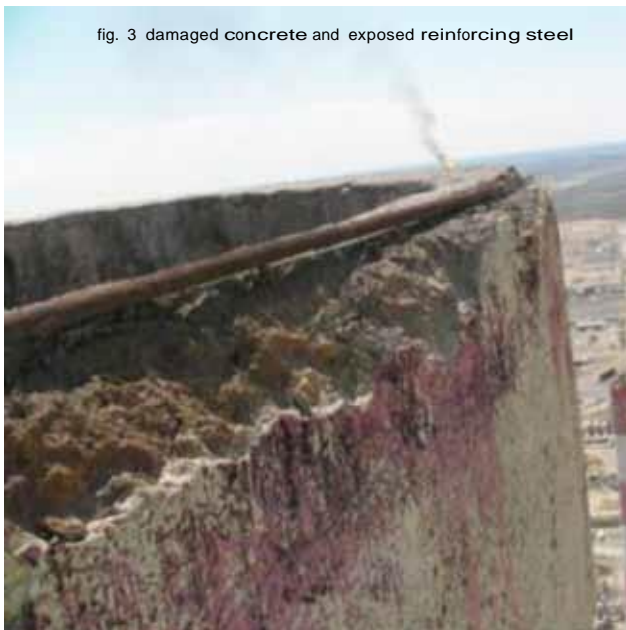
fig. 3 damaged concrete and exposed reinforcing steel

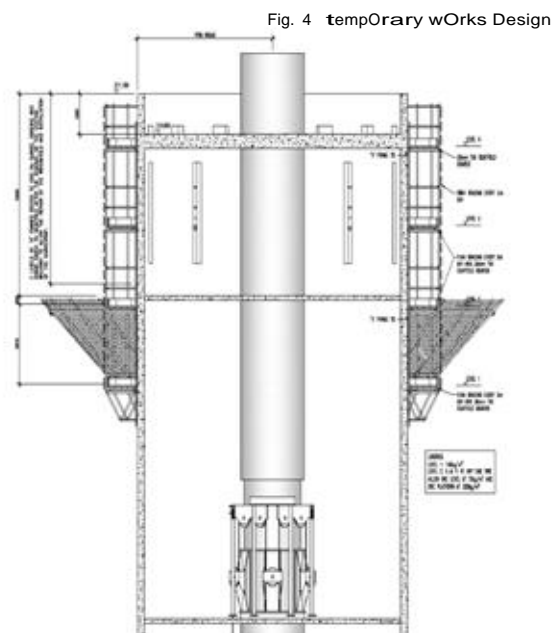
Fig. 4 tempOrary wOrks Design

In order to facilitate access to the work area, Zenith's Structural Engineering Department designed a full circumference scaffold to envelop the entire area complete with a fan deck at a position 6m below the chimney termination point. (Figure 4)

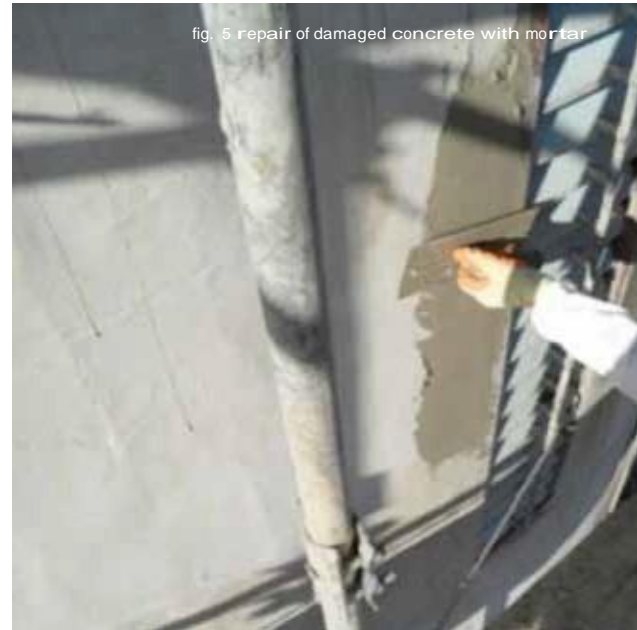
fig. 5 repair of damaged concrete with mortar

The temporary scaffolding was erected on the external face of the windshield, leaving a clearance of about one foot between the scaffold and the concrete surface to facilitate the installation of the fabric. All damaged and defective concrete had to be repaired to be suitable to receive the FRP system. Special structural mortar and patching materials were used for this purpose, targeting areas where surface was not even or sunken. (Figures 5 and 6).

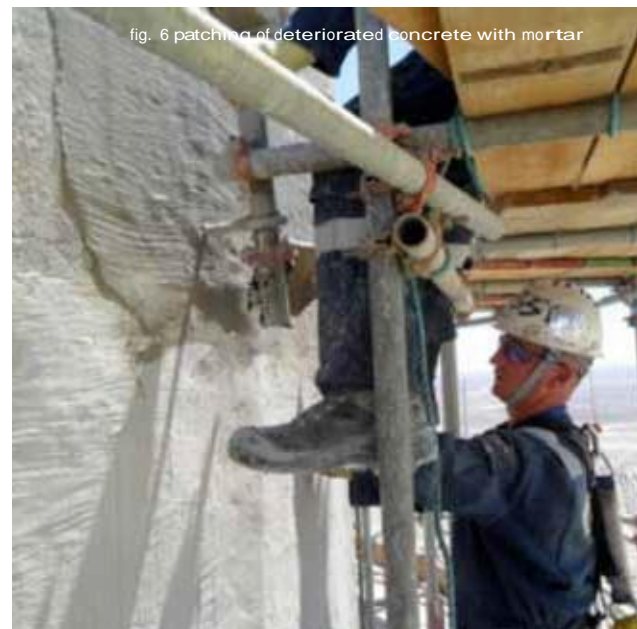
fig. 6 patching of deteriorated concrete with mortar

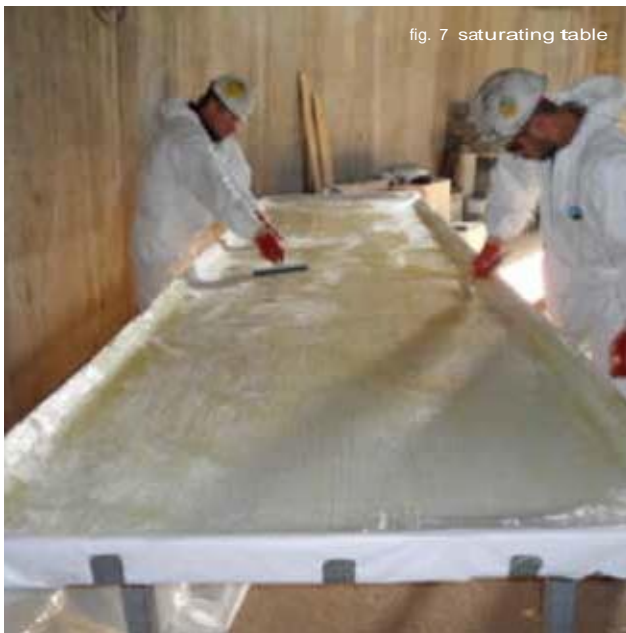
fig. 7 saturating table

A special saturating table was constructed at the bottom of the chimney (Figure 7). Pieces of fabric about 1.2 m wide x 6 m long were saturated with a two component epoxy resin. The option of performing this task at the top of the chimney was considered at first; however, due to space limitation and high winds, this option was ruled out. The saturated rolls of fabric were wrapped around a PVC tube for ease of transportation and handling.

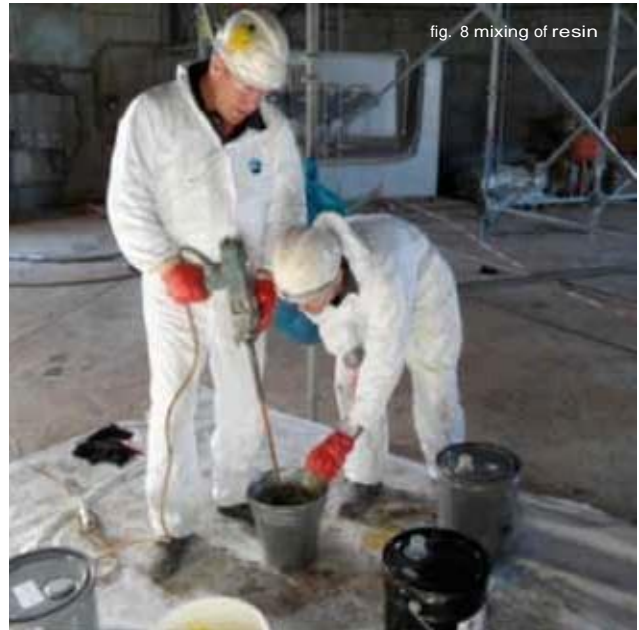
fig. 8 mixing of resin

Once the resin was mixed (Figure 8) and poured onto the fabric, the crew was against the clock since they only had close to twenty minutes from the resin mixing to the final installation of the fabric on its final destination. Usually, when resin starts to set while the fabric is being installed, it becomes difficult to handle and is not recommended to use it. Being on a remote location, wasting of materials due to temperature was not an option, therefore, special care was taken on the timing and handling of materials. Saturation of dry fabric and the application of the bonding agent (epoxy paste) were done simultaneously and by the time that the saturated fabric arrived on top, the coated surface was ready to receive the fabric, which created a nonstop routine.

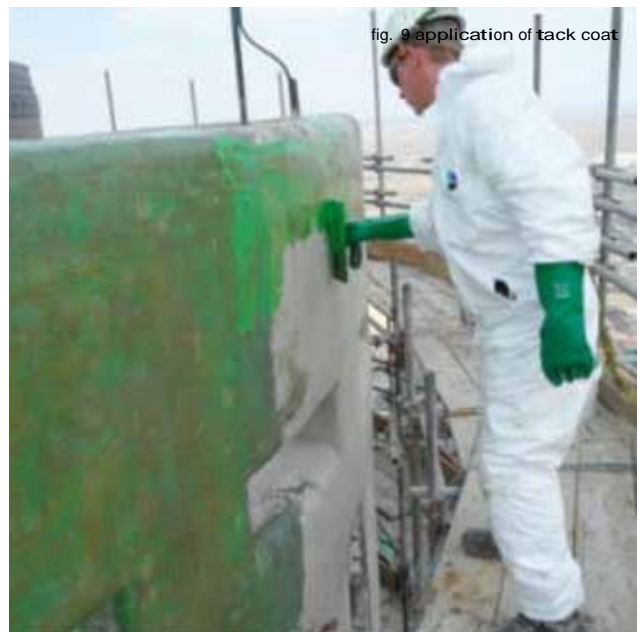
fig. 9 application of tack coat

As the first step of installation, a high-viscosity epoxy (Tack Coat) was mixed and applied with a trowel to the concrete surface (Figure 9). The thickness of this coating was approximately 1 mm. Installation process began at the interior-top part of the chimney (Figure 10), applying the fabric vertically and unrolling it all the way down (Figure 11), ensuring that any entrapped air between the fabric and the concrete surface was removed. A crew of four men performed this task on top of the chimney, where the high wind gusts often added to the challenge of the installation.

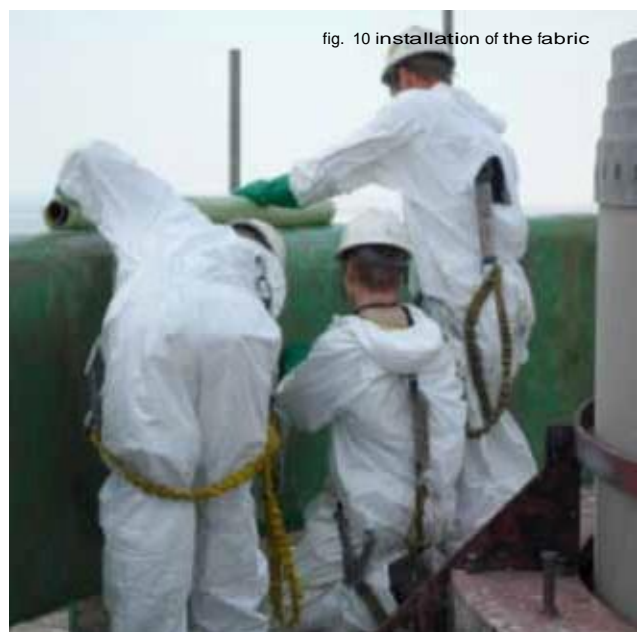
fig. 10 installation of the fabric

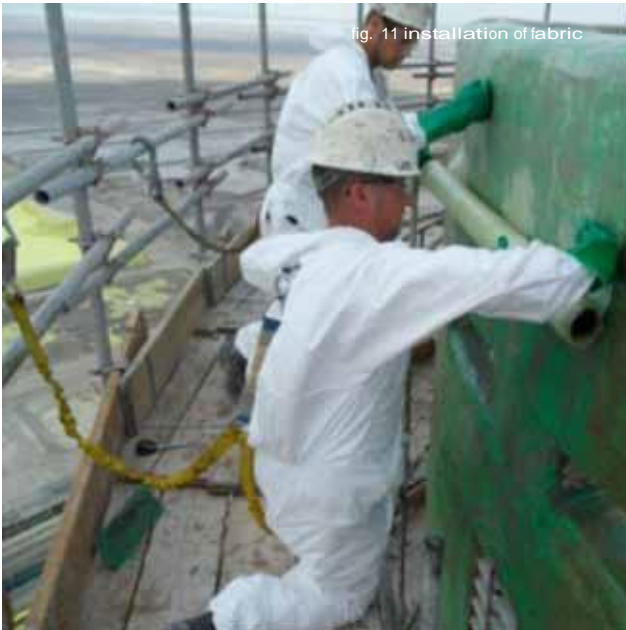
fig. 11 installation of fabric

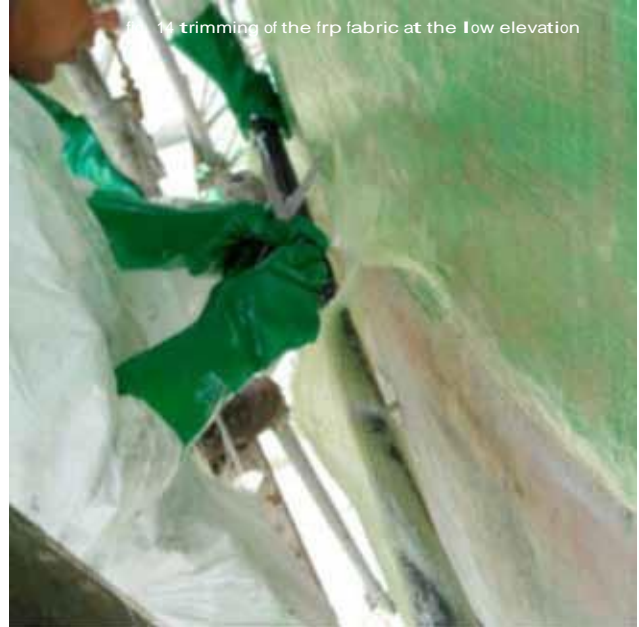
fig. 14 trimming of the frp fabric at the low elevation

The FRP fabric was cut and trimmed around the openings (Figure 12). This added a little extra time to the installation and on hot days care had to be taken to ensure that these activities could be completed before the epoxy would begin to set. Installation of the fabric was facilitated through a clearance of approximately one foot between the scaffold and concrete substrate (Figure 13) that allowed the fabric to go all the way down to the limits of the repair area, and then trimmed at the bottom (Figure 14).

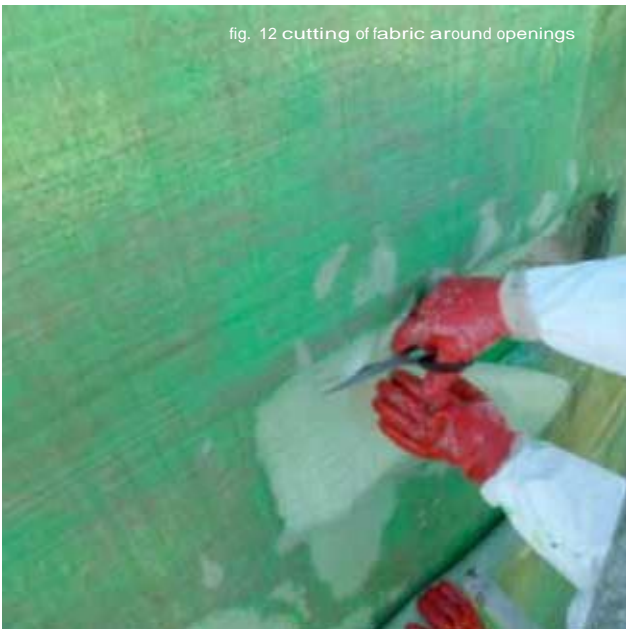
fig. 12 cutting of fabric around openings

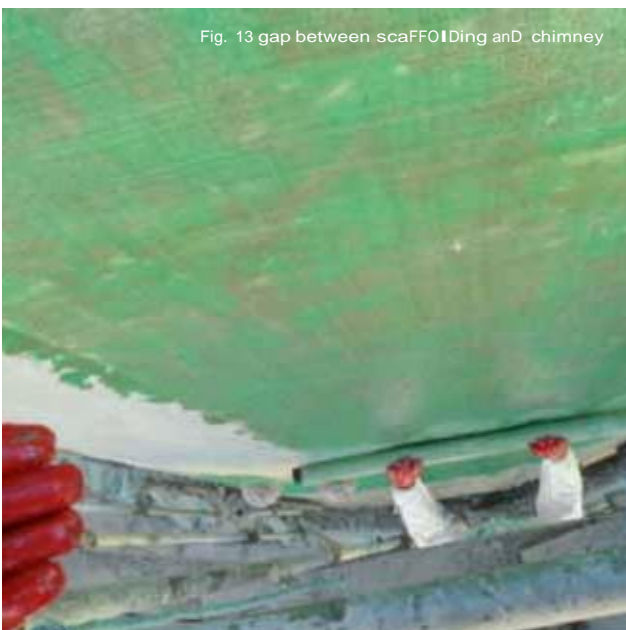
Fig. 13 gap between scaffolding and chimney

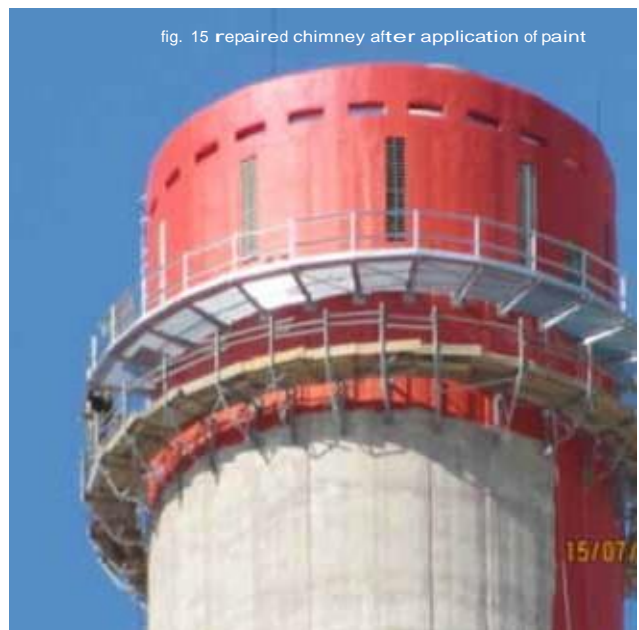
fig. 15 repaired chimney after application of paint

The FRP application process continued non-stop for four days at a height of 690 ft from the ground, checking and inspecting the quality of the application and repairing any imperfection that might have occurred due to the wind or other factors. After the FRP installation was completed, a special coating of chemical liquid plastic heat tolerant acid resistant paint was applied to the windshield area, restoring the original colour of the chimney (Figure 15).
