Access Issues Faced and the Technical Issues Raised Whilst Carrying Out Major Repairs to 4no Hyperbolic Cooling Towers

This paper considers the access issues faced and the technical issues raised whilst carrying out major repairs to four Hyperbolic Cooling Towers at British Energy's 2000MW Coal-fired Power Station at Eggborough in Yorkshire, England.

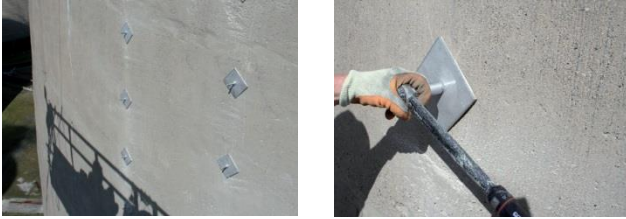
be a problem with the manufacturer requiring to turn additional thread and the replacement failure rate increased significantly with more waste generated. Photograph 4 shows typical placement technique.

As an alternative to the proposed theoretical bolting pattern, Zenith favoured continuous bolting in one direction. Bolting started to the right lower side of the delaminating area until each vertical row was complete before moving along to fit the next row in sequence. Once again an area of at least 1000mm was bolted beyond the delaminating area on both the vertical and horizontal planes. This had marginal result with the worst case being that minor chasing occurred. The benefits of this approach on productivity outweighed any negative issues. Typically the bolts were located at 1200mm on the horizontal plane and between 600-900mm on the vertical plane.

This product has excellent performance and longevity in this environment. The bolts are torqued to 60 Newton Metres.
