## Flare Tip Change out, Tengiz, Kazakhstan A Different Approach

This paper is intended to provide an overview of a flare tip change out, completed at Tengiz Oil Field, Kazakhstan, where circumstances dictated that a different approach to a repetitive and common project was required.

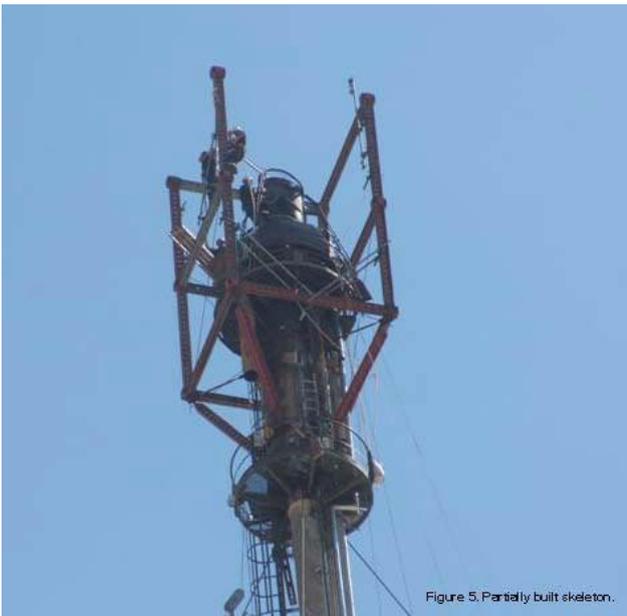
Figure 5 (photograph) depicts the partially built skeleton of the lifting davit. The components of the scheme were hoisted into position using an air driven winch bolted to a concrete foundation at ground level.

Following erection of the lifting davit skeleton, the runway beam was installed above the flare unit. The completed arrangement was inspected and tested prior to use. A number of further checks were also completed.

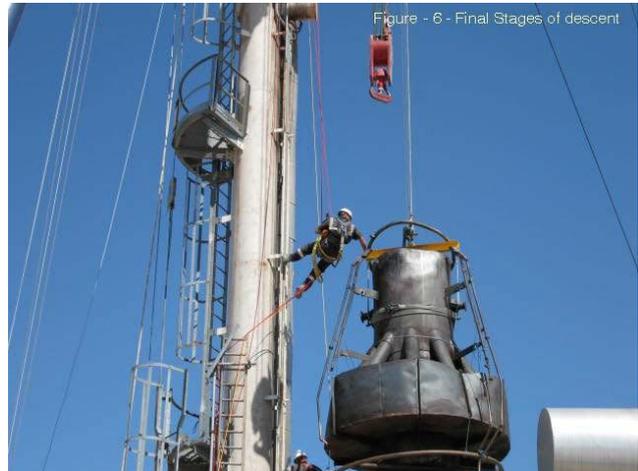
Figure 6 (photograph) shows the final stages of the descent with operatives guiding the defective flare tip past obstacles at lower level.

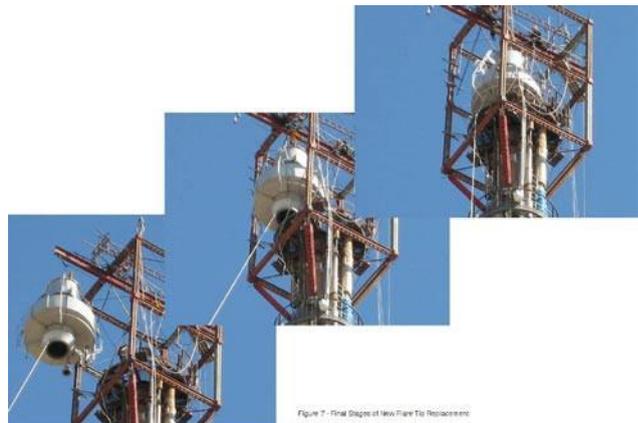
The installation of the replacement flare tip was completed in reverse order. Figure 7 (photographs) depict the final installation of the new arrangement.
