Re-strengthening of reinforced concrete chimney

This paper reviews the background, philosophy, repair scheme, scope and methodology used in the inspection and re-strengthening of a reinforced concrete chimney.

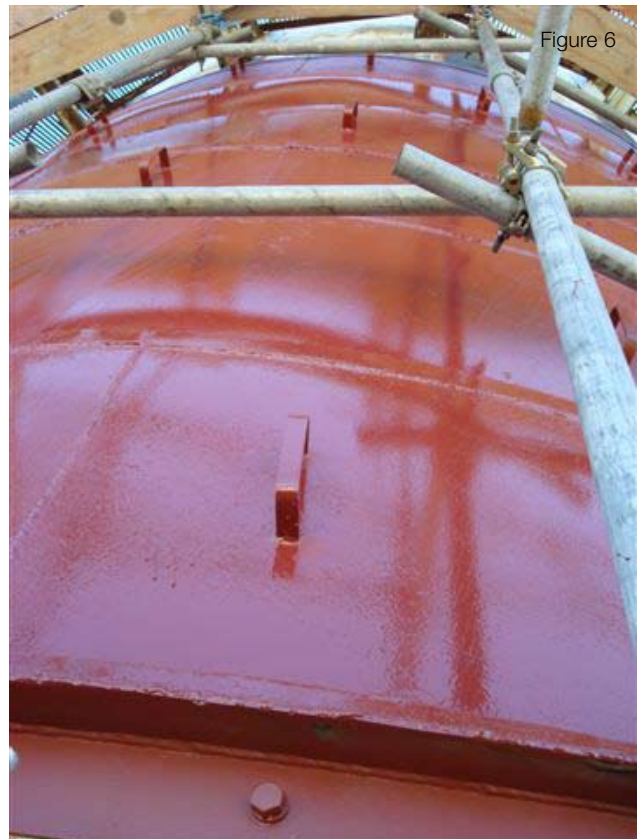
Figure 6

The initial step is to establish a definitive level for the repair scheme. In this scenario +111.00 meters from grade was the position of the support ring (Figure 5). The support ring is an angled ring beam bolted to the existing windshield. Following completion of the ring beam the steel 'sheath' construction can begin. The first course of steelwork is offered into position and tack welded into position. This is repeated until a full circumferential 'course' of steelwork is complete. Once the first course is complete the ring becomes self supportive. The final welding can then commence. Once completion of the first course of steelwork is complete the installation of the cementitious grout can commence. Simultaneous operations can then be considered with plate course construction and grouting being completed in parallel to reduce construction time (Figure 6). In practice the coursed steel construction continued to no more than one course prior to grouting. This allowed us to maximize repetitive working techniques without compromising on the quality control of the cementitious grouting.
